# **Navajo Abandoned Uranium Mine**

## **Site Screen Report**

### **Jim Lee - Richard King Claims AUM Site**

#### **Navajo AUM Northern Region**

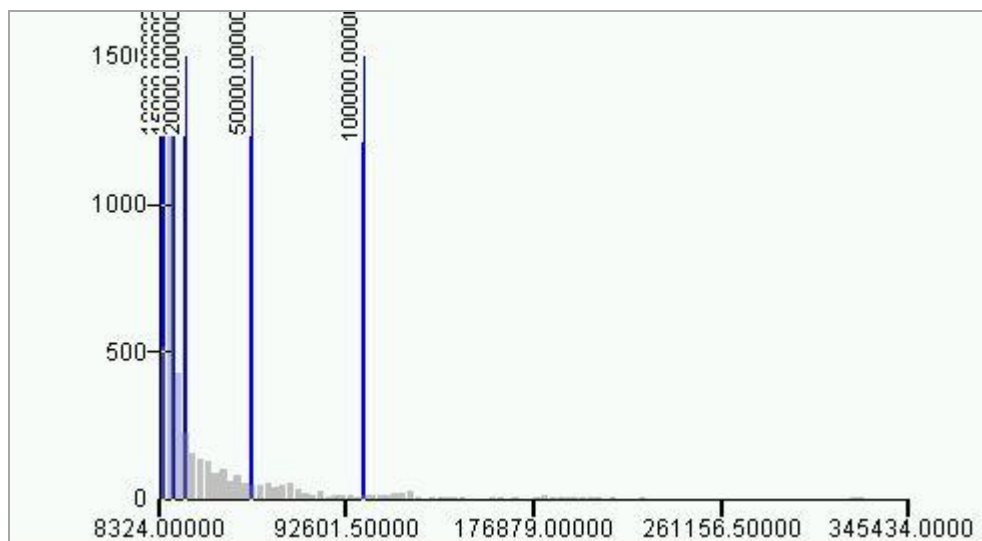
The following chart and statistics were generated by ESRI ArcGIS 9.3.1, and show the general distribution of the site gamma radiation measurements. The horizontal X axis represents the gamma radiation reading levels in cpm (lowest levels to the left). The vertical Y axis represents the frequency of each gamma radiation level.

Count:	3967
Minimum:	8324.00000
Maximum:	345434.00000
Sum:	138106386.00000
Mean:	34813.81044
Median:	16264.00000
Standard Deviation:	43961.01609

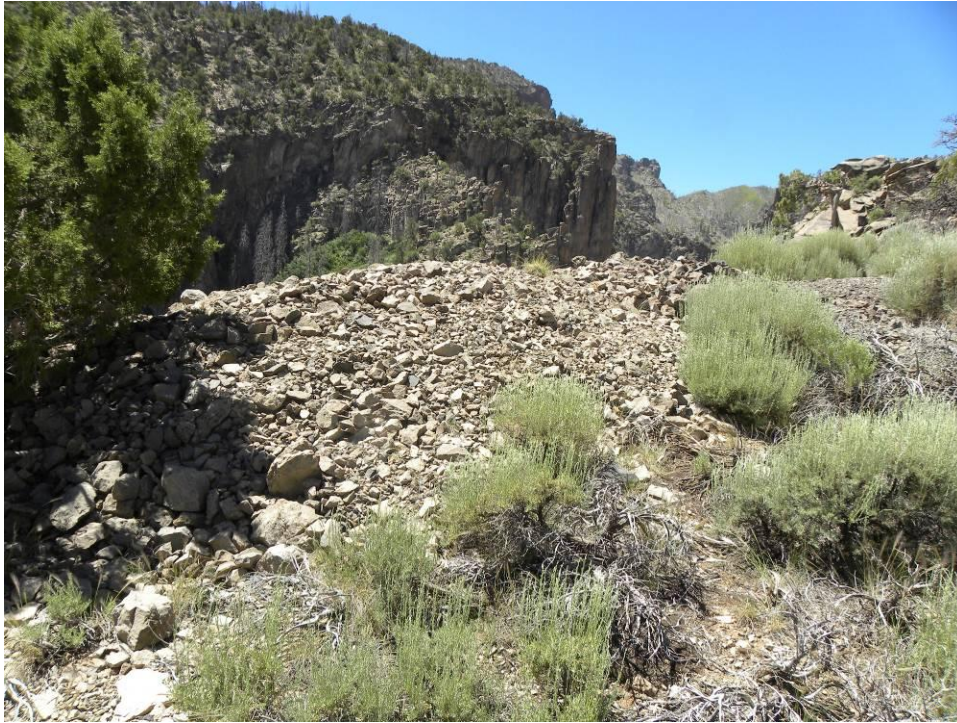
Four waste piles were noted onsite, all of which appeared to be unreclaimed: two waste piles bordering the ruined mining road on the way into the site; the larger waste pile was 30' x 12' x 4'; the smaller waste pile was 10' x 20' x 1.5'; two additional waste piles were observed extending down the slope immediately beneath adits; waste pile beneath adit 2 measured 40' x 40' x 10'; waste pile beneath adit 3 measured 30' x 80' x 3'

Photo 1. Large waste pile

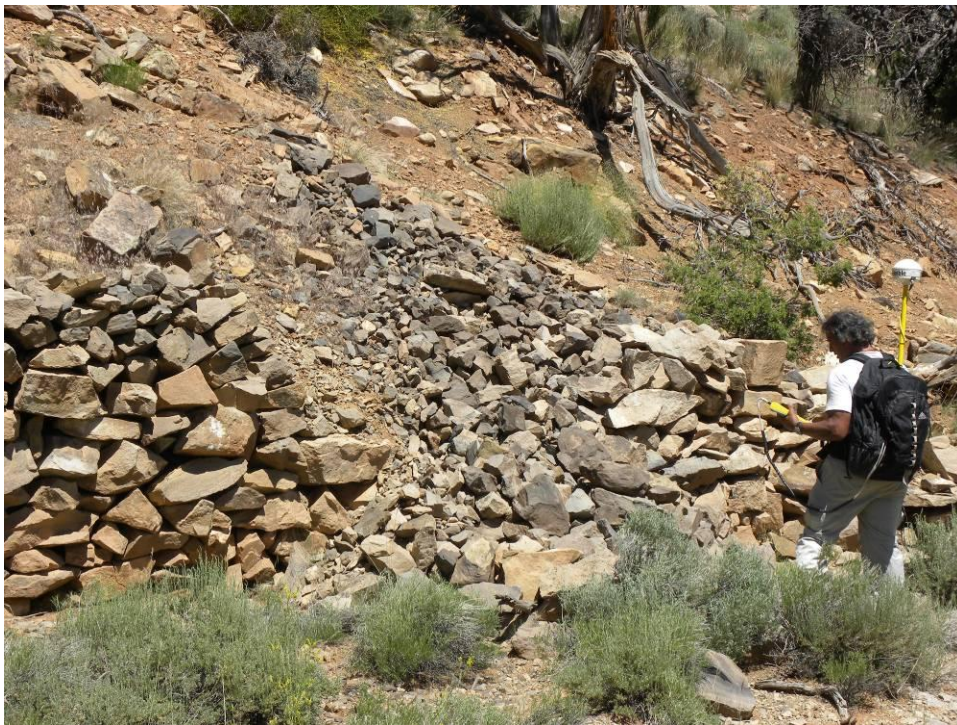
Photo 2. Waste pile and rock wall

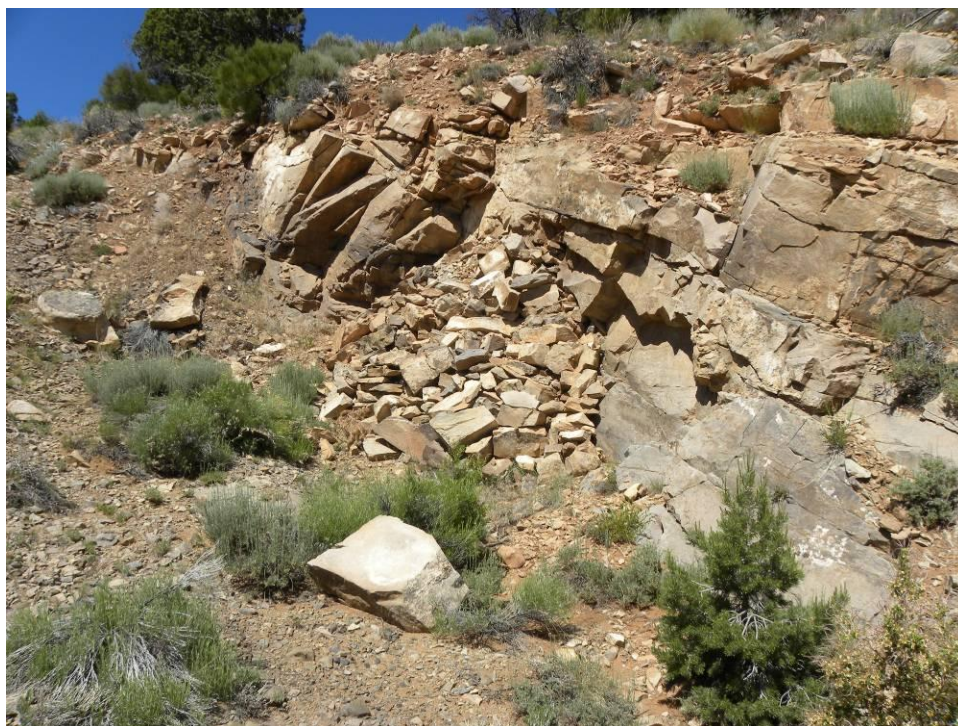
Three adits, each with stone reclamation seals: adit 1 was approximately 15' x 10'; adit 2 was approximately 20' x 10'; adit 3 was approximately 12' x 6'

Photo 3. Adit with stone reclamation seal

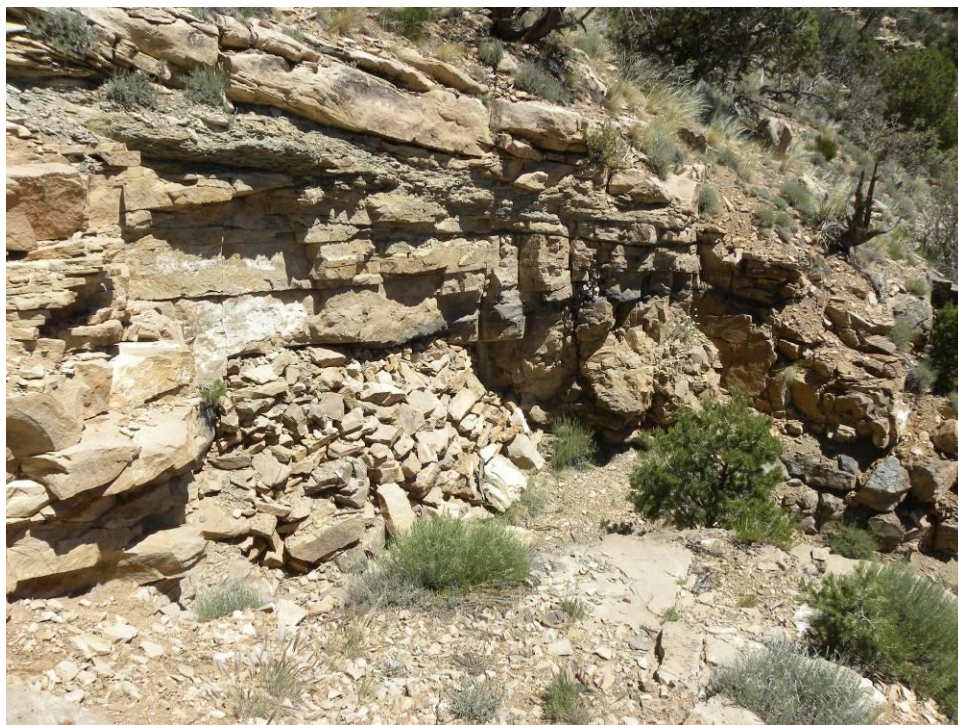
Photo 6. Adit with stone reclamation seal

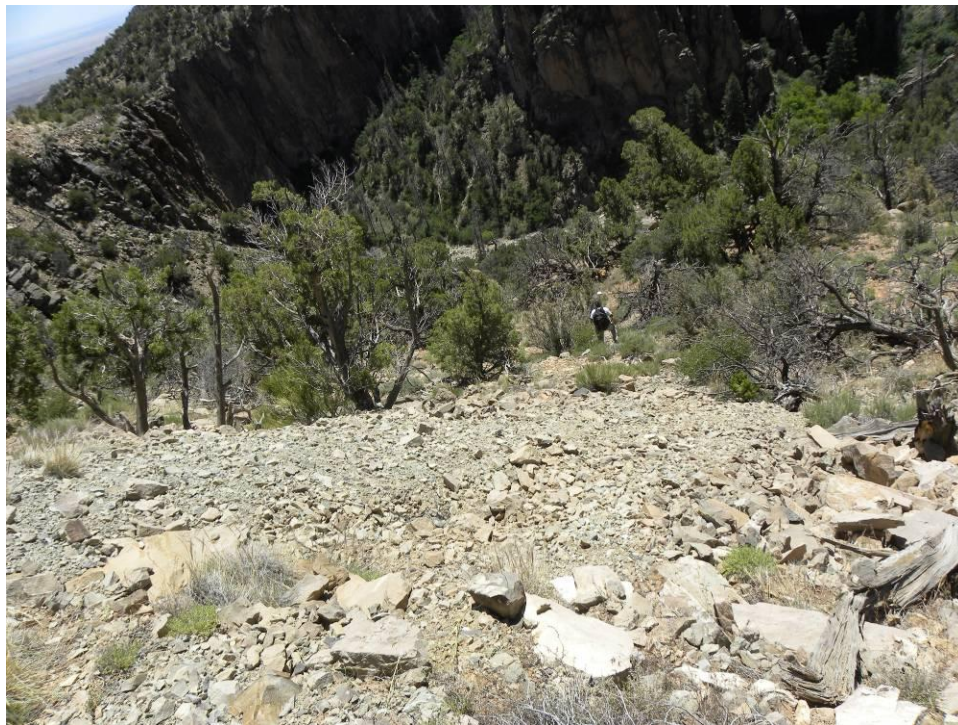
Photo 7. Large waste pile extending down slope

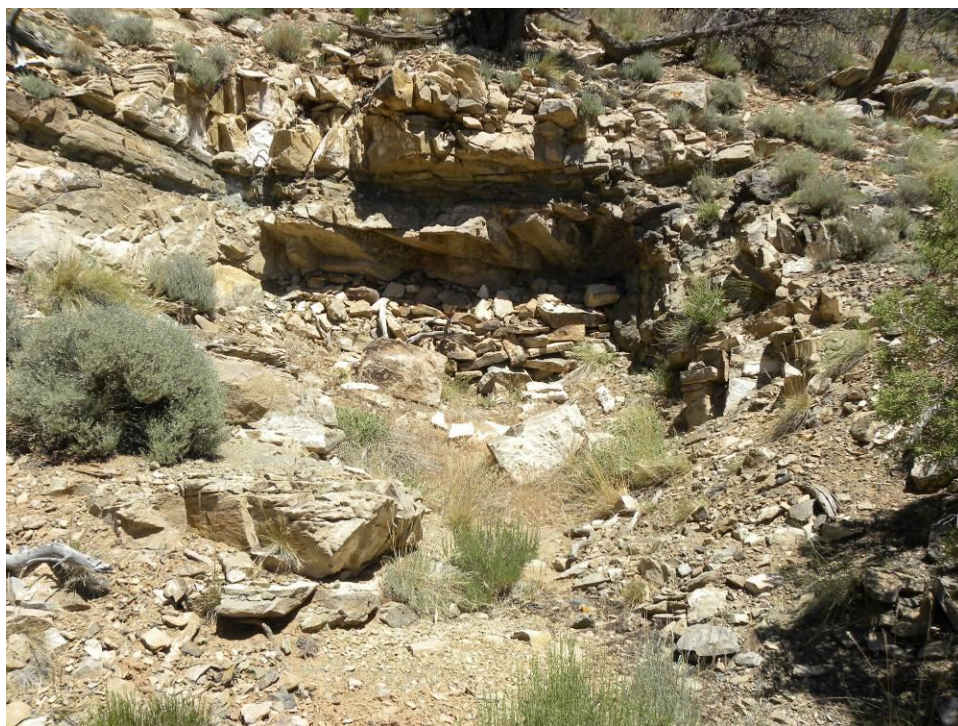
Photo 8. Adit with stone reclamation seal

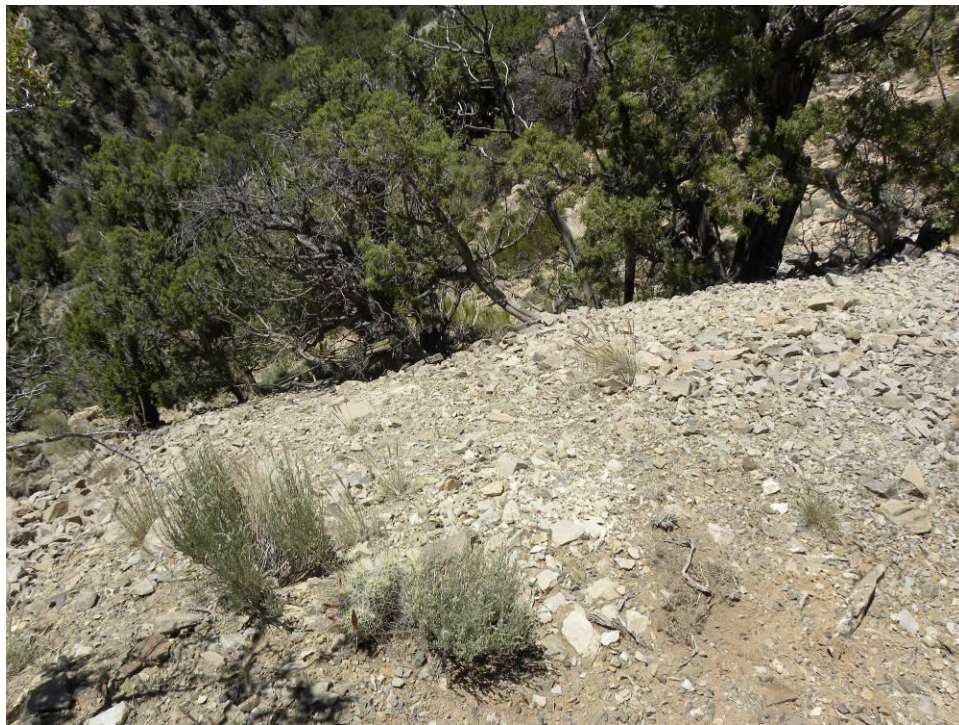
Photo 9. Waste pile extending down slope

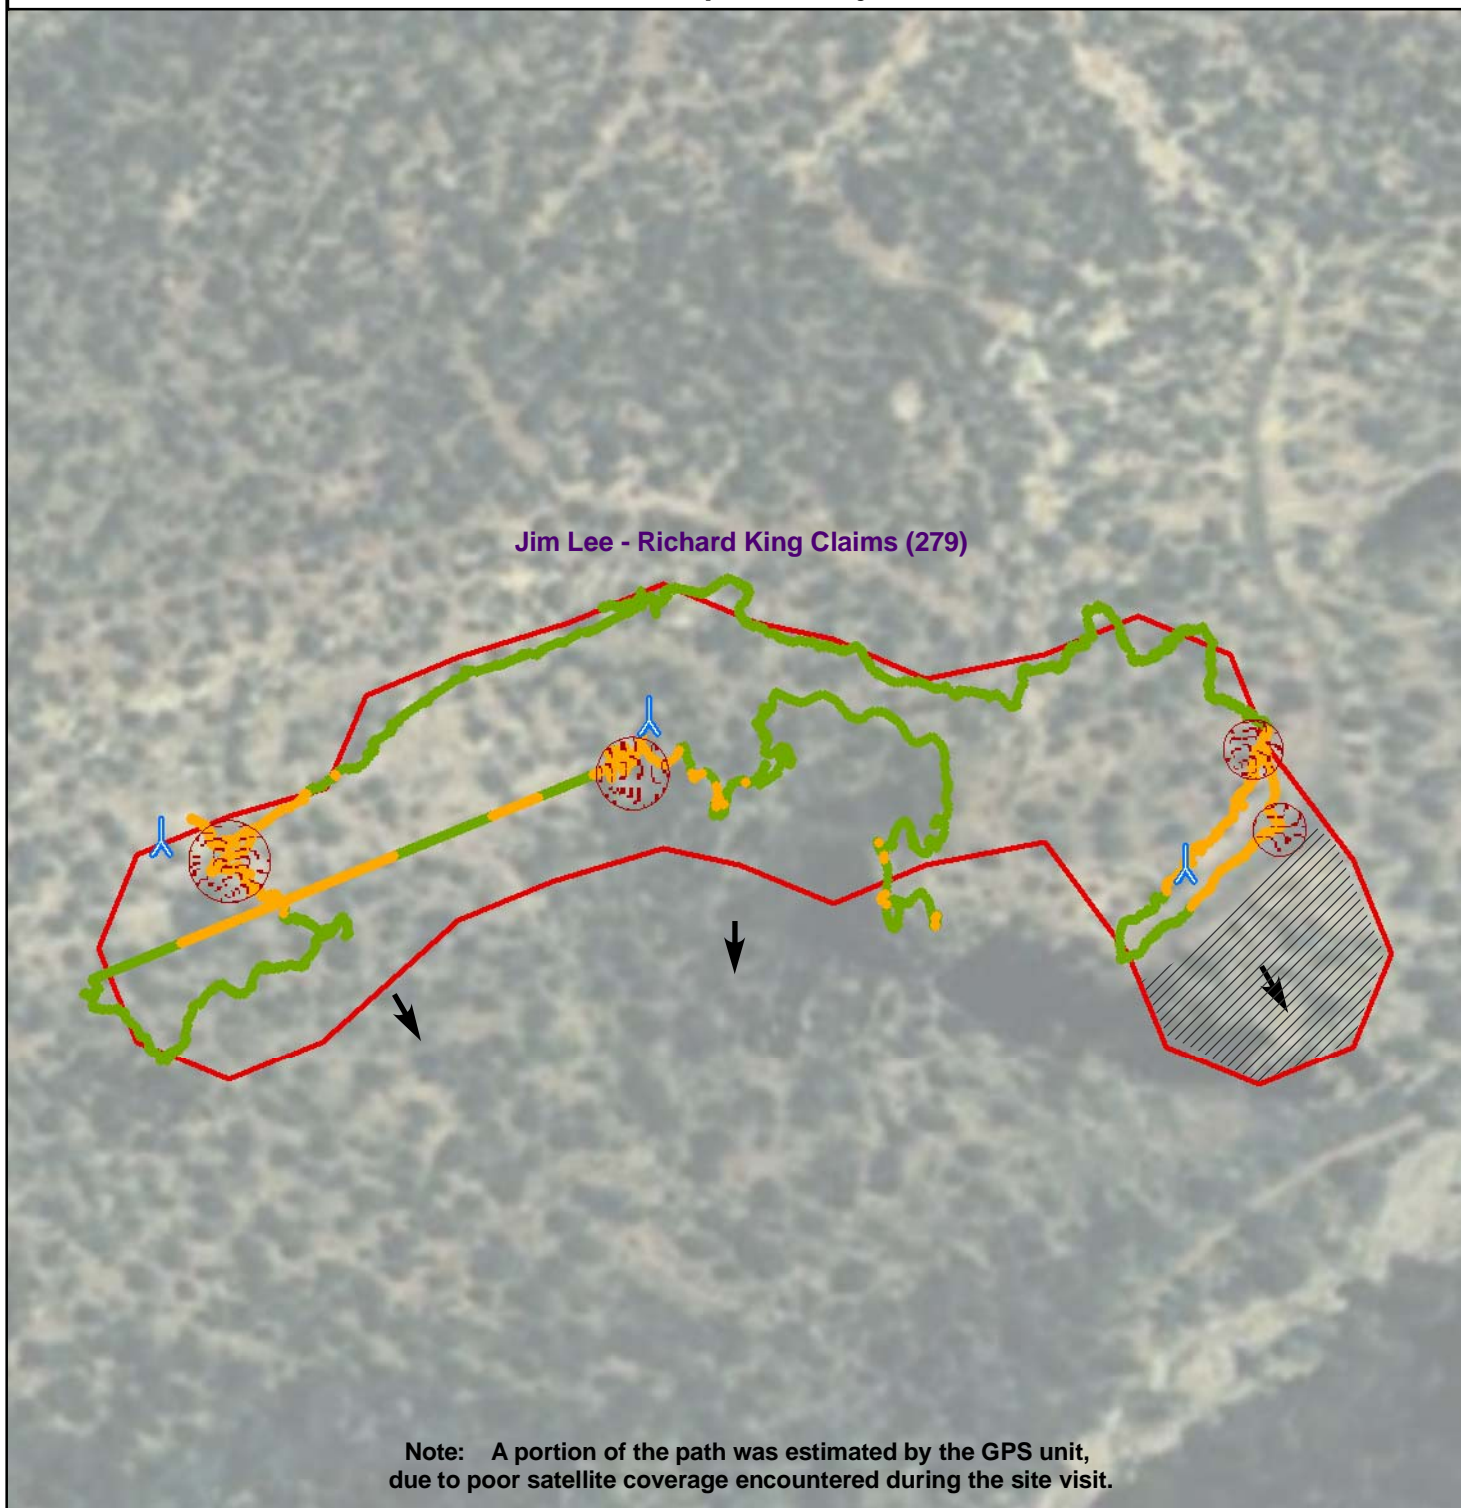
**Figure 1 - Gamma Radiation Measurements, Above Two Times Background**  
**Jim Lee - Richard King Claims (279)**  
**Beclabito Chapter, Navajo Nation**

A total of 3,967 gamma radiation measurements were collected from the mine site, ranging from 8,324 cpm to 345,434 cpm. Measurements collected in the vicinity of the waste debris were found at levels ranging from approximately 50,000 cpm to 330,000 cpm, and near the adits at levels ranging from approximately 50,000 cpm to 115,000 cpm. The measurements are represented in Figures 1 and 2.

Gamma survey conducted 06/2010  
 Measured as counts per minute (cpm)

Average background = 11,580 cpm

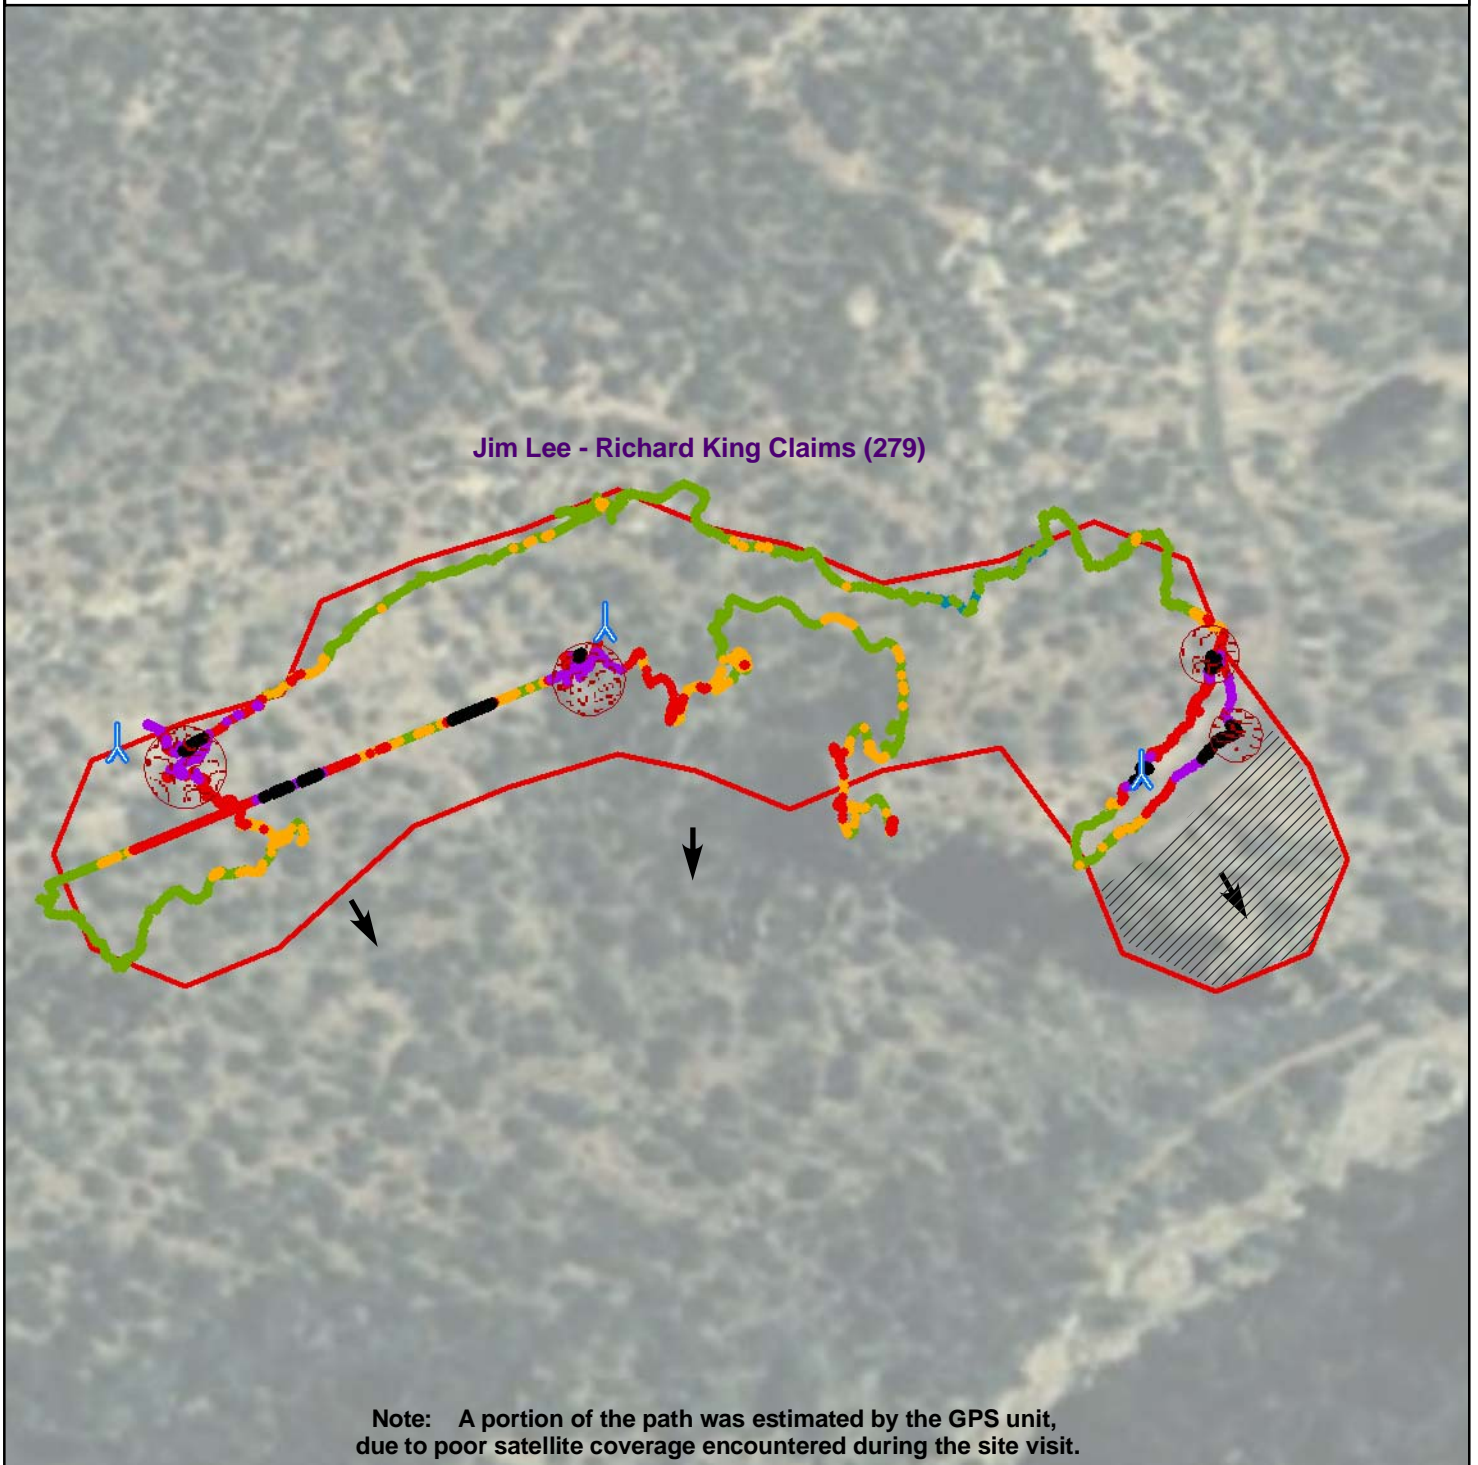
**Figure 2 - Gamma Radiation Measurements**  
**Jim Lee - Richard King Claims (279)**  
**Beclabito Chapter, Navajo Nation**

Gamma survey conducted 06/2010  
 Measured as counts per minute (cpm)

Average background 11,580 cpm
